**Flood Control Project Maintenance
Levee Inspections**

Fall 2016 Levee Maintenance Deficiency Summary Report

Reclamation District No. 2096 Wetherbee Lake

Levee Inspection Report By Mile - Fall 2016

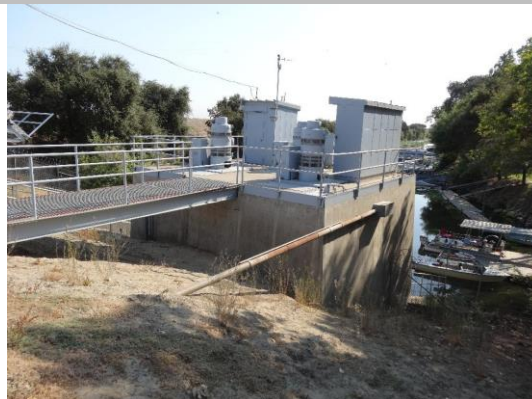
Photo 1 of 2 : UCIP_FA_2016_21506_36453.jpg

LM Start	0.03	Rating **	M	Issue No.	14
LM End	0.03	Issue Type +	En	Location *	N/A
Category	Supplemental			GPS Latitude/Longitude	
				Start	End
Item	DWR UCIP Field Study			37.773800 °	37.773800 °
				-121.298428 °	-121.298428 °
DWR ID					
Comment Code					
Inspector Comment					
FS_ID:21506					
DS_ID:24666					
EP_NO: N/A					
Repair Type: Non-Urgent					
Crossing Status: Found					
UCIP Comments: - more information needs to be find from LMA/DWR					
Inspector for this crossing. - needs to find whether this pipe passes					
through the levee.					
FIELD_STRUCT_DESC: A 4-inch steel pipe through the levee and to					
pump platform, 3 ft. below the crown. It is a element of pumping plant.					
Field study discovered utility crossing.					
FS Date: 9/10/2013

LS view: 4-inch steel pipe (right) through the levee and to pump platform.

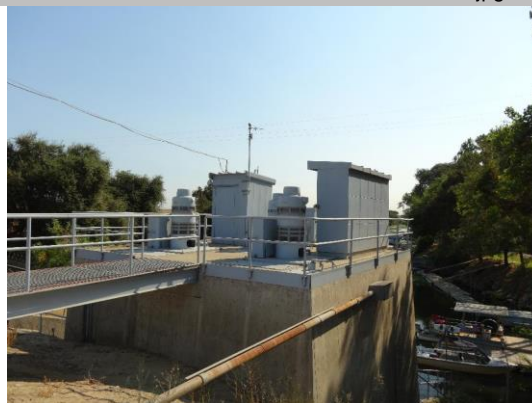
Photo 2 of 2 : UCIP_FA_2016_21506_36452.jpg

LS view: closer view of 4-inch steel pipe (left) through the levee and to pump platform.

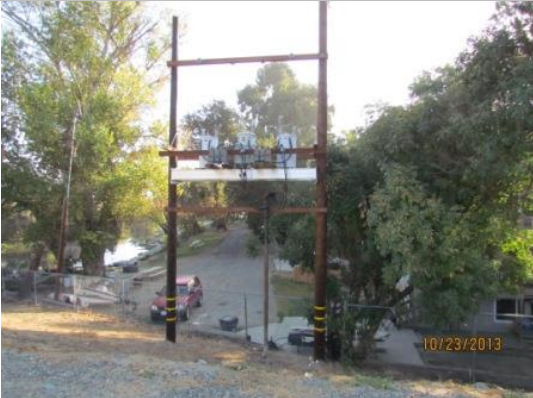
Photo 1 of 1 : FA_2016_RD2096_117_8_20160914_00003.jpg

View of the telephone poles at the landside levee toe.

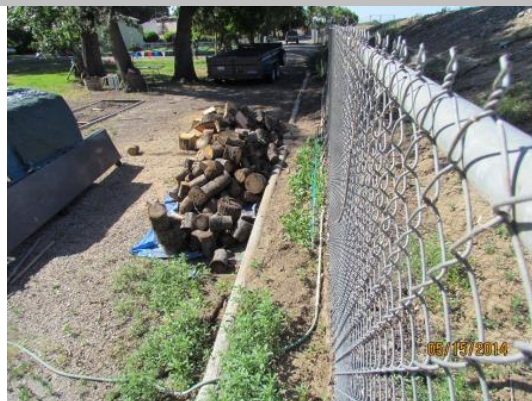
Photo 1 of 1 : FA_2016_RD2096_117_13_20160914_00007.jpg

LM Start	0.08	Rating **	M	Issue No.	13
LM End	0.08	Issue Type +	En	Location *	LS
Category	Earthen Levee			GPS Latitude/Longitude	
				Start	End
Item	Encroachments			37.773021 °	37.773021 °
				-121.298430 °	-121.298430 °
DWR ID	DWR_RD2096_01_s_2014_13				
Comment Code					
RW : Retaining Wall					
Inspector Comment					
Abut 1 foot by 50 feet retaining wall at levee toe with irrigation and landscaping.

View of the retaining wall at the landside levee toe.

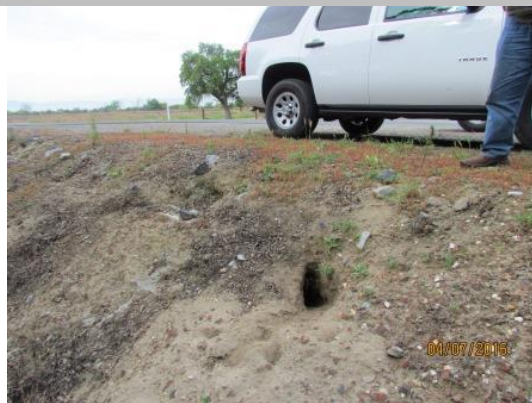
Photo 1 of 1 : FA_2016_RD2096_117_6_20160914_00002.jpg

LM Start	0.09	Rating **	A/W	Issue No.	6
LM End	0.09	Issue Type +	Ma	Location *	LS
Category	Earthen Levee			GPS Latitude/Longitude	
				Start	End
Item	Animal Control			37.772891 °	37.772891 °
				-121.298454 °	-121.298454 °
DWR ID	DWR_RD2096_01_s_2016_6				
Comment Code					
A3 : No rodents visible, but rodent burrows visible; need to backfill and compact or grout burrows.					
Inspector Comment					
LMA has effective rodent control program. Monitor this location for possible future activity.

View of the rodent hole on the landside levee slope.

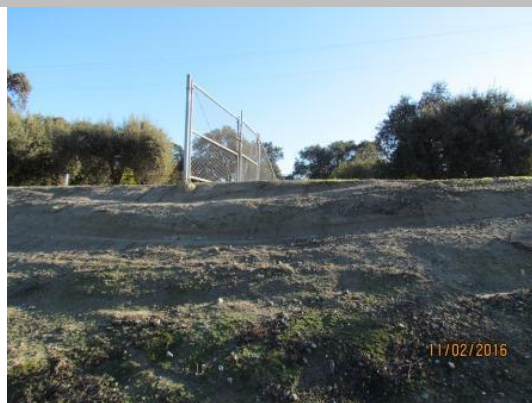
Photo 1 of 3 : FA_2016_RD2096_117_11_20161104_00010.jpg

View of the waterside slope damaged by vehicle.

LM Start	0.12	Rating **	M	Issue No.	11
LM End	0.12	Issue Type +	Ma	Location *	WS
Category	Earthen Levee			GPS Latitude/Longitude	
				Start	End
Item	Slope Stability			37.772434 °	37.772434 °
				-121.298433 °	-121.298433 °
DWR ID	DWR_RD2096_01_s_2015_11				
Comment Code					
S3 : Repair the levee slope damaged by vehicle traffic and prevent access where possible.					
Inspector Comment					
Regrade and re-compact damaged waterside levee slope.

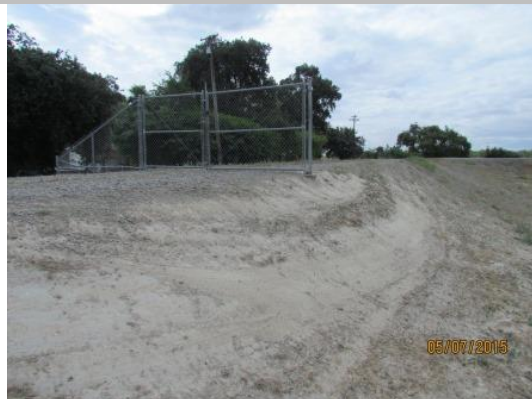
Photo 2 of 3 : FA_2016_RD2096_117_11_20160914_00005.jpg

View of the vehicle tracks eroding the waterside levee slope.

LM Start	0.12	Rating **	M	Issue No.	11 (cont)	
LM End	0.12	Issue Type +	Ma	Location *	WS	
Category	Earthen Levee			GPS Latitude/Longitude		
				Start		End
Item	Slope Stability			37.772434 °		37.772434 °
				-121.298433 °		-121.298433 °
DWR ID	DWR_RD2096_01_s_ 2015_11					
Comment Code						
S3 : Repair the levee slope damaged by vehicle traffic and prevent access where possible.						
Inspector Comment						
Regrade and re-compact damaged waterside levee slope.

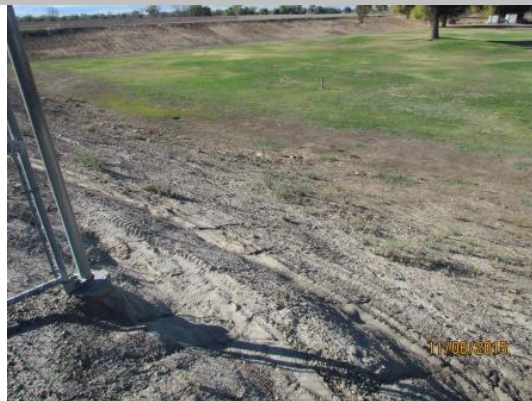
Photo 3 of 3 : FA_2016_RD2096_117_11_20160914_00006.jpg

Another view of the vehicle tracks on the waterside levee slope.
